U.S. DEPARTMENT OF TRANSPORTATION
OFFICE OF INSPECTOR GENERAL

**Weaknesses in FAA's Certification and
Delegation Processes Hindered Its
Oversight of the 737 MAX 8**

Report No. AV2021020

February 23, 2021

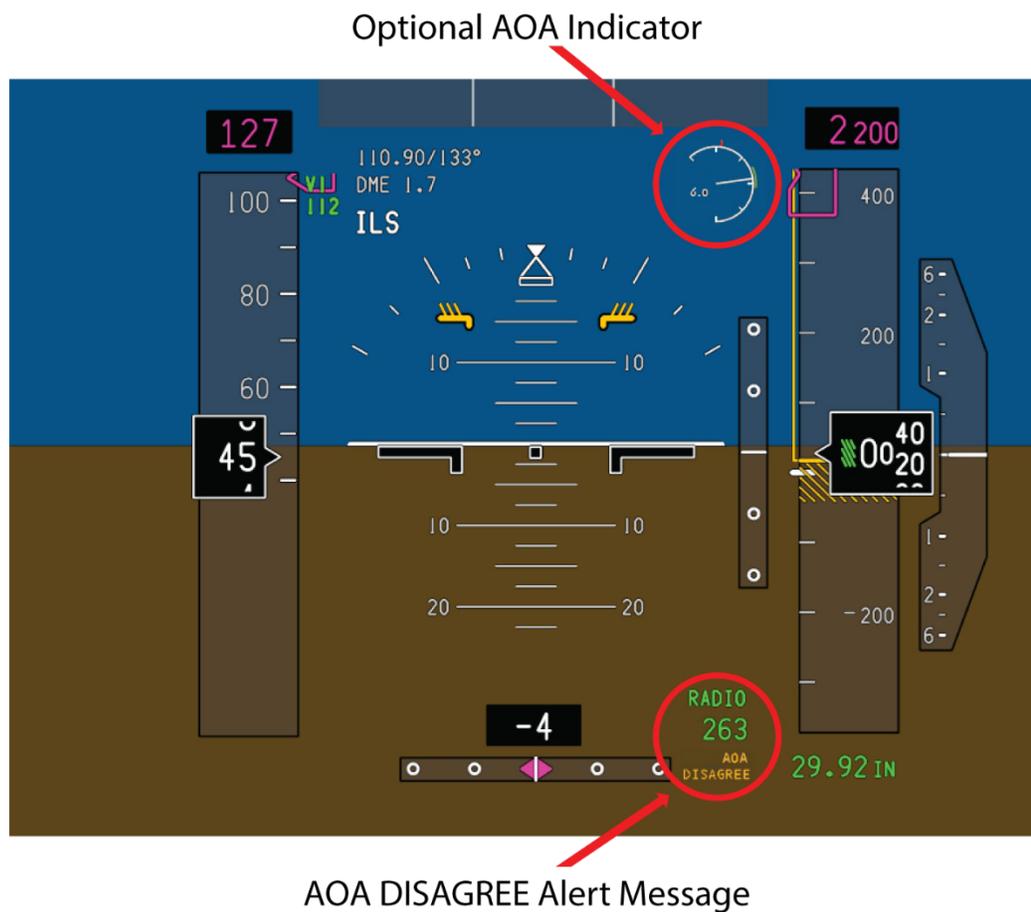
Figure 8. AOA Disagree Message and AOA Indicator

According to Boeing representatives, they analyzed the issue and determined that the cockpit alert was not “necessary for the safe operation of the airplane” because there were no required procedures or pilot actions associated with the alert. Boeing documented the problem and planned to have the problem corrected for the entire MAX fleet by late 2020. According to Boeing representatives, the AOA disagree cockpit alert message issue was included in updated certification documents in September 2017 that were approved by an ODA engineering unit member on FAA’s behalf. Boeing did not have to submit a formal notification of the issue directly to the FAA oversight office since company analysis had determined that there was not an “operational impact” as a result of the cockpit alert issue. Documentation we reviewed from February 2019 and FAA representatives we interviewed agreed with Boeing’s determination that it was not an unsafe condition.

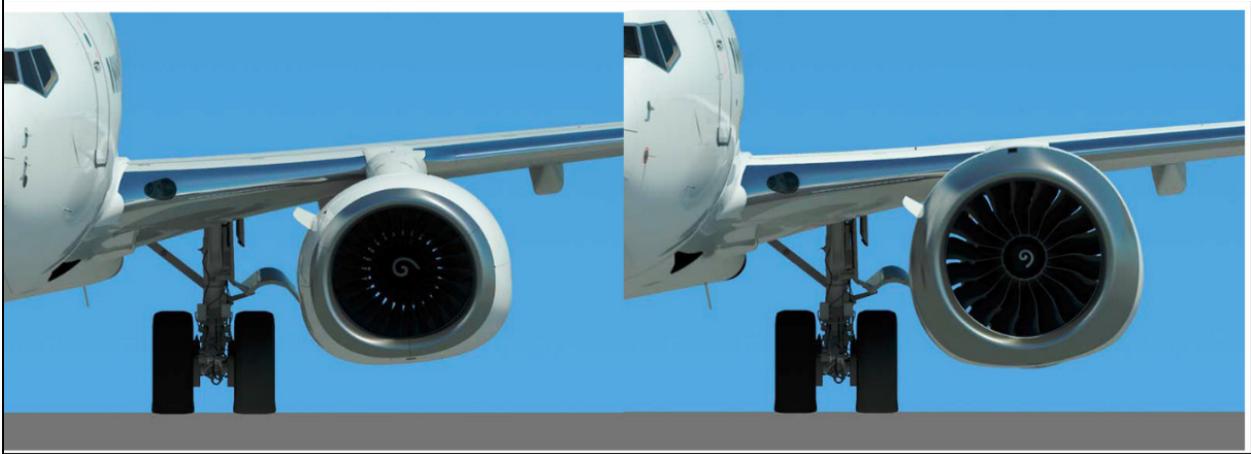
Engine Size and Placement: 737 NG (pictured left) vs. 737 MAX (pictured right)

Boeing developed MCAS for the 737 MAX 8 to compensate for changes in aerodynamics from the previous model caused by the MAX's larger engines and the placement of those engines on the wing.

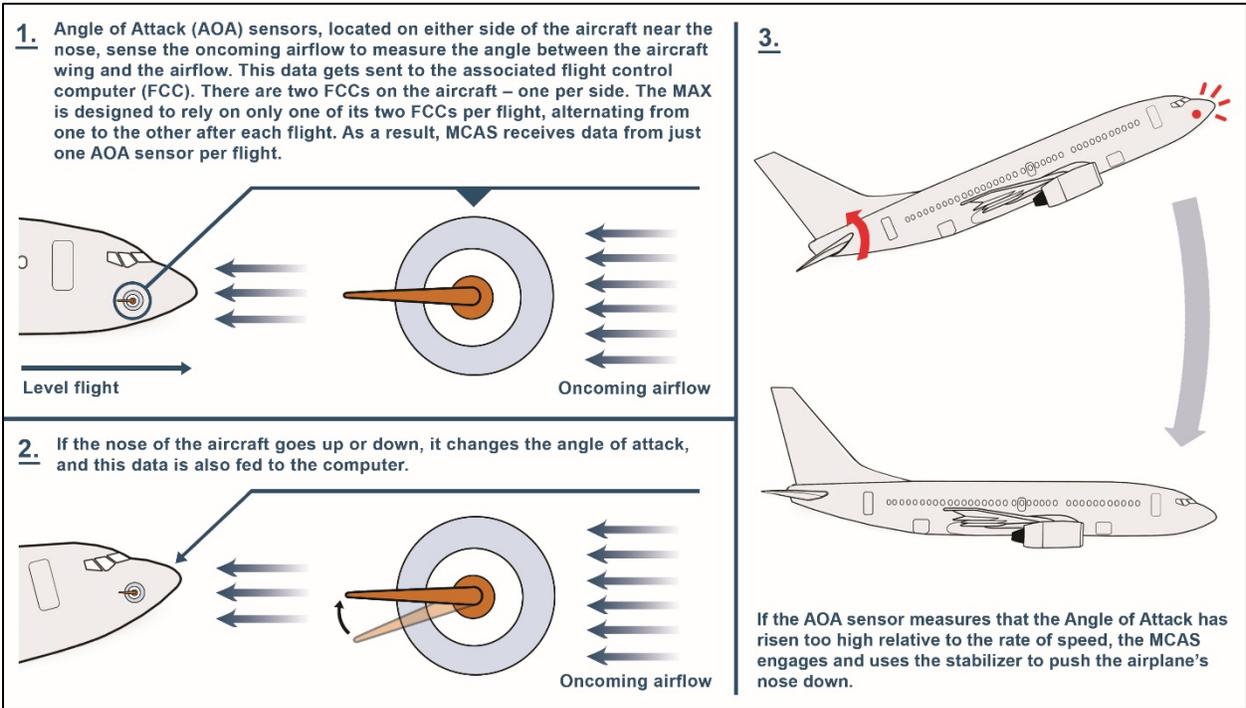
How MCAS Works on the 737 MAX

angle of the aircraft in the air—known as angle of attack (AOA).²² While not its primary intent, MCAS can, under certain failure conditions, have the effect of moving the plane’s nose down during manual flight if not counteracted by the pilot. (See exhibit E for more details on the functionality of MCAS.)
