For Release on Delivery
Expected at
10:00 a.m. EDT
Wednesday
September 17, 2008
CC-2008-120

**FAA's Certification
of the Eclipse EA-500
Very Light Jet**

**Statement of
The Honorable Calvin L. Scovel III
Inspector General
U.S. Department of Transportation**

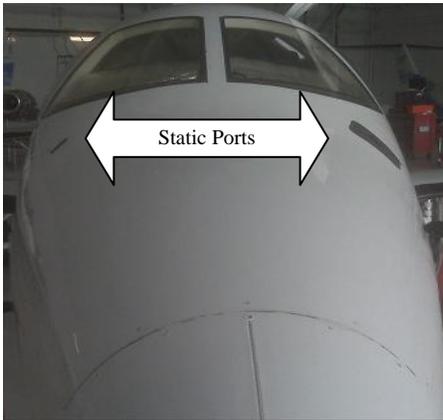
Figure 3. EA-500 Nose Pitot-Static Ports

The source of these problems was eventually traced to moisture build-up inside the pitot-static system. This occurred due to the unusual placement of the static ports on the top of the aircraft nose (see figure 3 below) and the lack of drainage; the static ports are normally located on the sides of the aircraft to mitigate moisture.

Federal aviation regulations require that “the design and installation of each air speed indicating system must provide positive drainage of moisture from the pitot-static system.” However, FAA can approve a non-typical design by granting the manufacturer an “Equivalent Level of Safety” (ELOS) exemption. In this instance, FAA granted an ELOS for the EA-500 pitot-static tube as proposed by the manufacturer. The ELOS was based on Eclipse’s assertion that the pitot-static system included a heating system designed to dry any moisture that might accumulate.

In response to the pitot-static system problem, FAA issued an AD on June 14, 2007, limiting operations of the aircraft to two-pilot operations only and only under visual flight rule conditions.⁴ FAA issued a second AD that was effective on February 26, 2008. This AD lifted the restrictions for those aircraft whose owners had installed the design modification for the pitot-static system developed by Eclipse for existing aircraft. However, users we spoke with told us that while the modification required by the AD has helped reduce the number of incidents, it has not eliminated the problem.
