Office of Inspector General
Audit Report

***Oversight of Manufacturer's Quality
Assurance Systems for Threaded Fasteners***

Federal Aviation Administration

Report Number: AV-2001-003

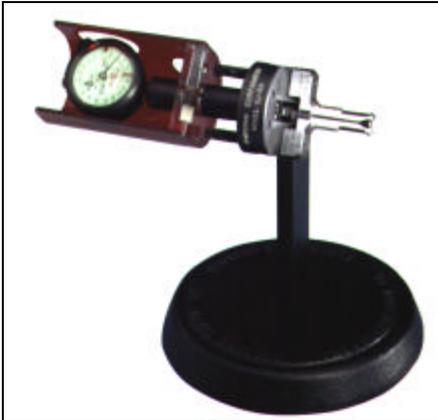
Measuring Device for Internal Threads

use the equipment prescribed in FAA-approved design data for testing thread dimensional conformance of aviation nuts. The design data require the use of precision equipment that can provide minute measurements. However, these two manufacturers used a go/no-go gage, which is a simple test of whether a nut will assemble with a mating bolt. These measuring devices are shown as follows.

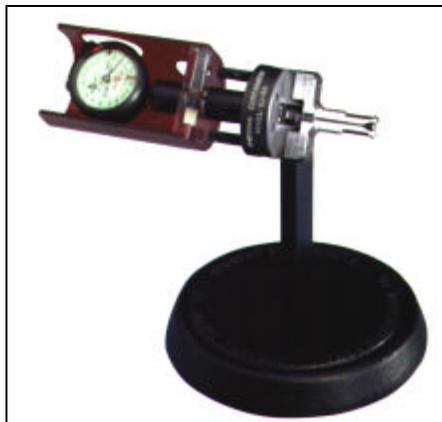
Measuring Device for Internal Threads

However, quality inspectors at two of Boeing's subcontractors⁷ did not use the equipment prescribed in MIL-S-8879C to test thread dimensional conformance of crimped nuts. MIL-S-8879C requires the use of precision equipment that can provide minute measurements. However, these manufacturers used a go/no-go gage, which is a simple test of whether the nut would assemble with a mating bolt. This device does not test to the precision prescribed in the specification.

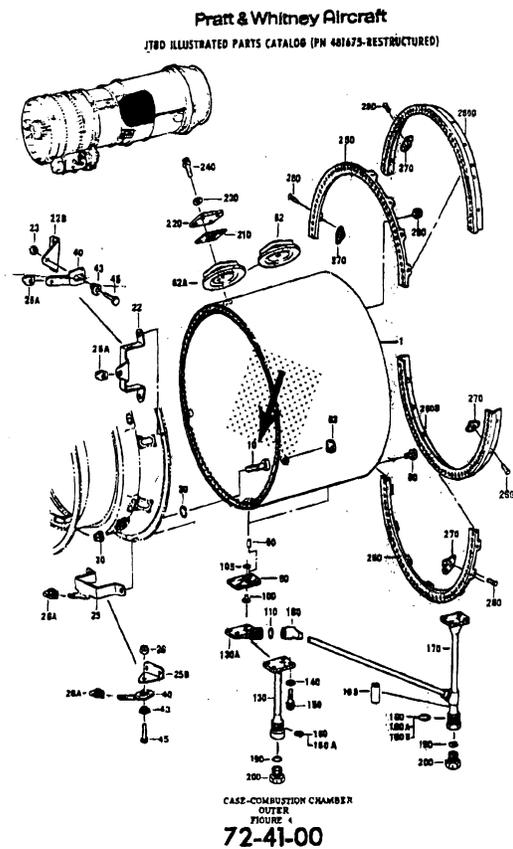
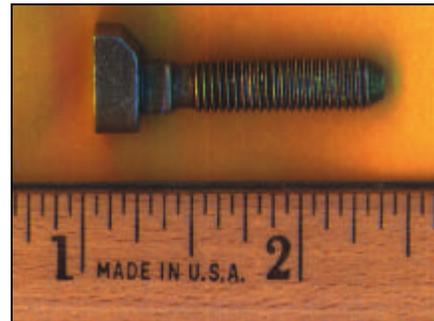
Defective Bolt, Part Number 772568QQ

FAA inspectors determined that, from March to December 1999, the defective bolts failed on 10 engines used on commercial passenger aircraft, causing internal damage to 7 engines and 1 in-flight shutdown. Analysis of the failed bolts revealed an insufficient nickel content, which was traced to an error during the manufacturing process. Because of insufficient nickel content of the fasteners and the high-temperature operating environment of turbine engines, these bolts became brittle and failed, causing internal engine damage. The manufacturer determined that approximately 24,400 defective bolts were sold and about 400 engines on aircraft operated by major air carriers could be affected. No accidents resulted; however, this quality control lapse cost one air carrier approximately \$100,000 to remove the defective bolts and monitor engine performance. Also, based on cost data obtained from one repair station, the average cost to repair engines that sustained damage was \$400,000 per engine.

Although the bolt pictured below appears to be insignificant in size, its failure caused internal damage to seven engines and one in-flight engine shutdown. The industry must continue to monitor the engines where these bolts have been installed and be alert to identify these bolts in maintenance inventories and avoid installing them on any additional aircraft.

The defective fasteners were used in a critical application to hold the combustion chamber outer case in place on Pratt & Whitney JT8D engines as shown to the left. JT8D engines power many commercial passenger aircraft, including the Boeing 727, Boeing 737, MD-80 and DC-9 aircraft. During overhaul of the engine, 90 of the bolts are replaced.

FAA investigation of this case revealed weaknesses in the production approval holder's monitoring of subcontractors. The FAA production approval holder had subcontracted the manufacturing of this fastener. The subcontractor then subcontracted the plating process. FAA inspectors determined this second-tier subcontractor was processing a large volume of parts for the commercial aviation industry. *FAA concluded that all parts processed by this subcontractor were suspect because of serious quality control problems, such as improperly calibrated equipment and lack of evidence that the company followed required quality procedures.* The production approval holder had never inspected this second-tier subcontractor, and the first-tier subcontractor had not conducted an audit of the company since July 1995.

- ✓ removing all of these bolts from inventory;
- ✓ performing a records search of all engines that have this bolt installed;
- ✓ removing and replacing the bolts for all uninstalled engines with fewer than 200 hours in service;
- ✓ placing all engines that have this bolt installed on a maintenance watch program to identify signs of performance degradation, such as high vibration; and
- ✓ removing and replacing the suspect bolts if turbine damage is evident.
