## FAA Has Completed 737 MAX Return to Service Efforts, but Opportunities Exist To Improve the Agency's Risk Assessments and Certification Processes

Federal Aviation Administration | AV2023025 | April 26, 2023

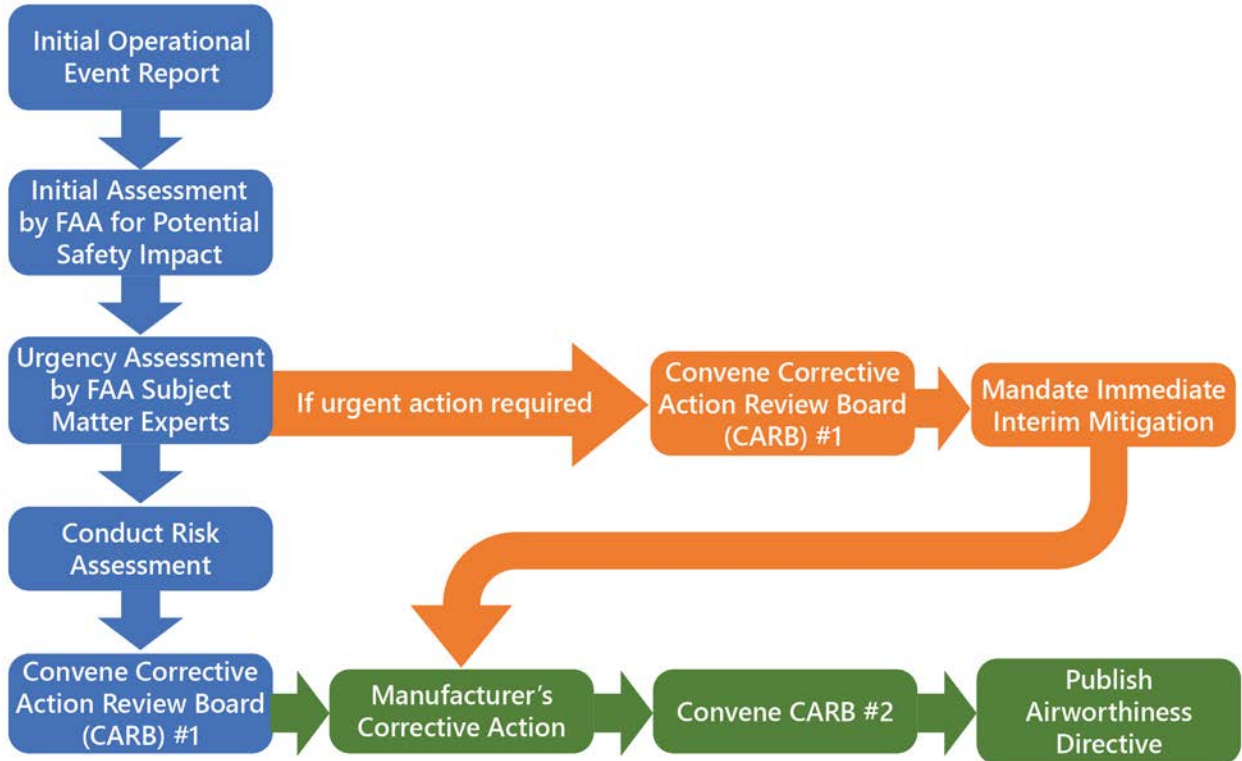
report events to FAA, including failures, malfunctions, and defects. FAA filters the operational reports to determine potential safety events for further review and conducts an urgency assessment based on the reports to determine if immediate action is needed, such as an Emergency Airworthiness Directive (AD) or aircraft grounding. ACO engineers then conduct a quantitative risk analysis and compare the results with established guidelines to determine if action is recommended. The Corrective Action Review Board<sup>15</sup> (CARB) formally reviews the results to determine if there is an unsafe condition, urgency of action, and what action is required. Later, the CARB also reviews and approves the manufacturer’s proposed corrective action(s) and determines the maximum time recommended to implement a fix, based on the risk analysis. Finally, FAA formally mandates the action by AD. FAA can require interim corrective actions to reduce risk while the final action is in development.

Figure 1. Key Steps<sup>16</sup> in the Continued Operational Safety Process

Following all reported potential operational events for transport category aircraft, FAA Aircraft Certification Offices (ACO) use the risk-based Continued Operational Safety process to determine if an unsafe condition exists in an aircraft fleet, and to develop corrective actions. For certain reported events and conditions, such as failure of a part during flight or the discovery of a regulatory noncompliance, FAA's Continued Operational Safety process assesses risk post-certification to ensure an acceptable level of safety in every seat on every flight. (See figure 1 for a general overview of the process.) Under the process, aircraft manufacturers

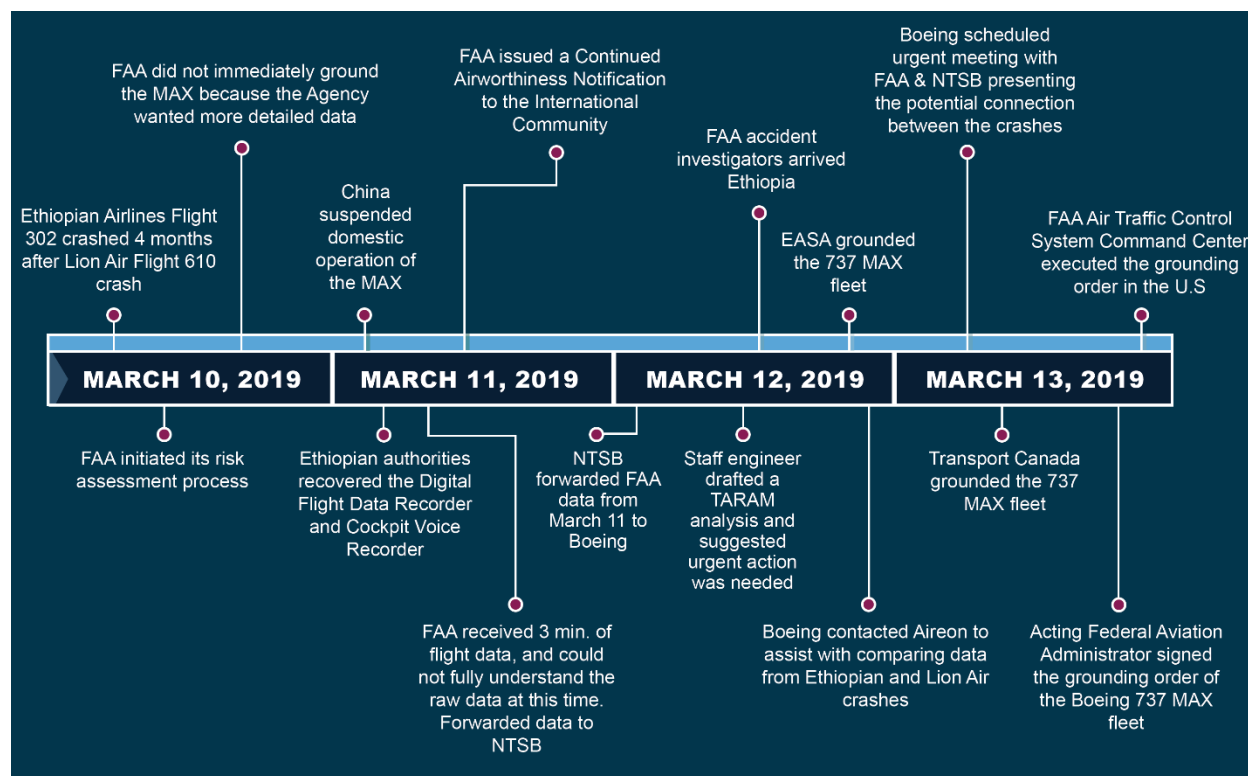
Figure 2. Timeline of Events Following the March 2019 Ethiopian Airlines Accident

Agency grounded the Boeing 787 Dreamliner in 2013. (See figure 2 for a more detailed timeline of events for the grounding of the 737 MAX.)
